HIGHWAY RESEARCH REPORT

DYNAMIC TESTS OF WOOD POST AND TIMBER POLE SIGN SUPPORTS SERIES XV

NO. M & R 636398

Prepared in Cooperation with the U.S. Department of Transportation, Bureau of Public Roads December, 1967

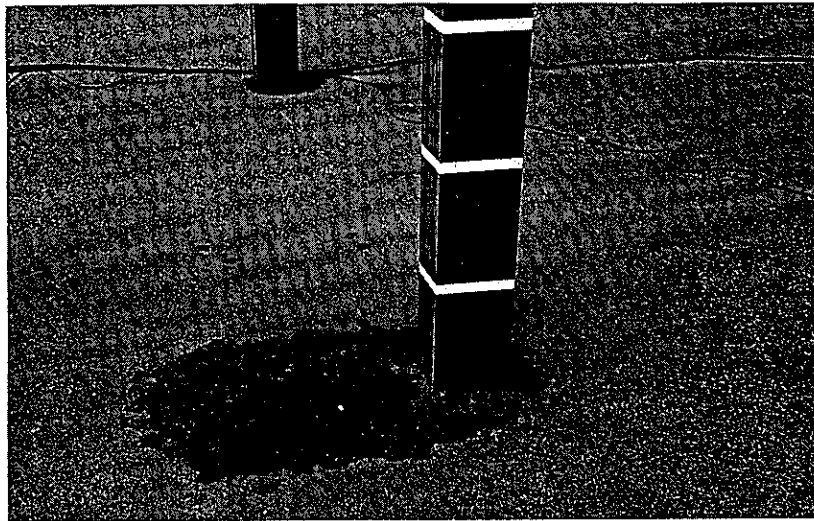
FIGURE 1

The test site for this study was a portion of an unused airport runway (Exhibit 1). The runway is surfaced with a two inch thick asphalt pavement with no imported base material. To simulate a typical operation installation, the asphalt surfacing was removed from behind each wood post or timber pole support to be impacted for a minimum distance of 24 inches as shown in Figure 1 below.

This allowed the impacted support to dynamically deflect horizontally on impact and transmit shear forces to the soil with no interference from the surrounding asphalt pavement.

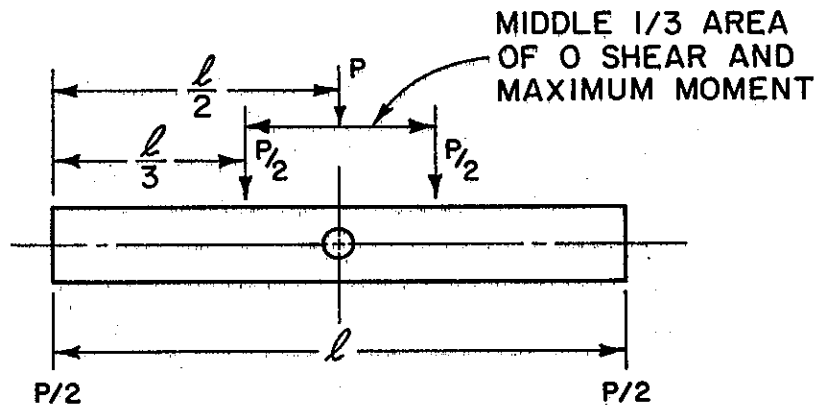
FIGURE 4

As a laboratory check of the theoretical effect a reduction in cross sectional area has on ultimate moment carrying capacity, six static load tests were performed on 8" x 8" x 6' D.F. posts. The cross sectional areas of two of the posts were reduced 30% by drilling a 2½" diameter hole through the post along its neutral axis. The remaining four posts were not altered. Third point loading, as shown in Figure 4 below, was used to minimize the effect of shear. Theoretically the middle one third of the beam will resist maximum moment and shear forces will be negligible.

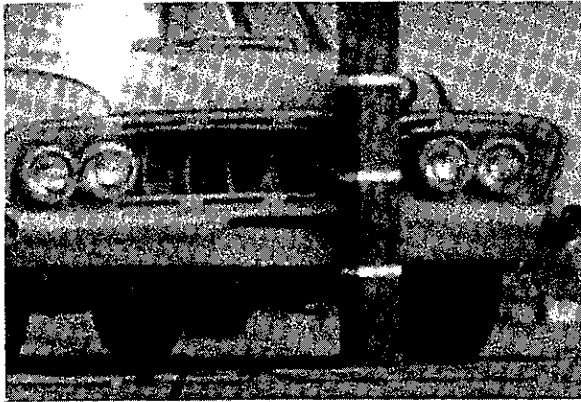
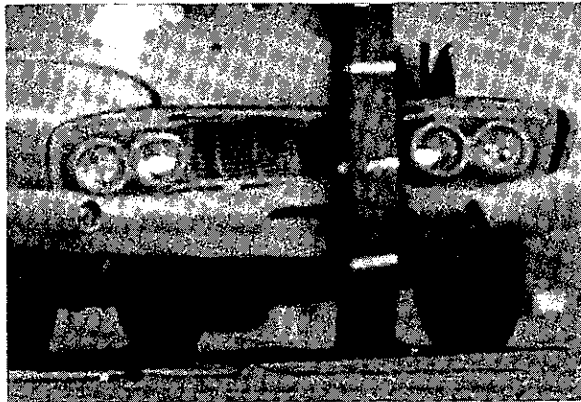
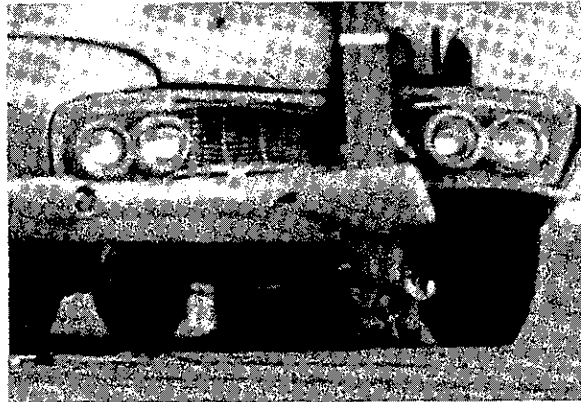
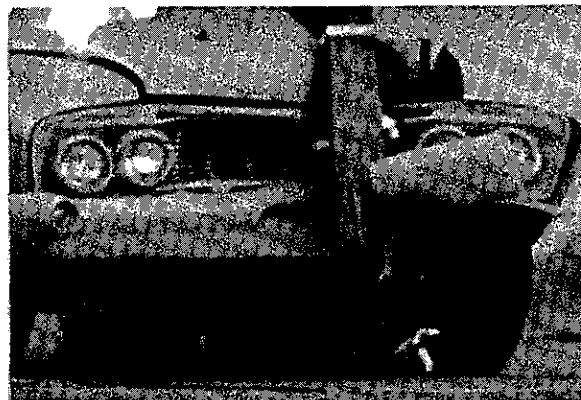
TEST 151 PLATE A

The impacted post sheared at ground level and was propelled upward and to the right by the force of impact. The pole tore loose from the lower panel, pulling the mounting bolts through the sign panel, but remained attached to the upper panel which it twisted and bent as it swung in an arc down and to the right of the right support post. Neither sign panel could be salvaged.

The vehicle sustained moderate front end damage.

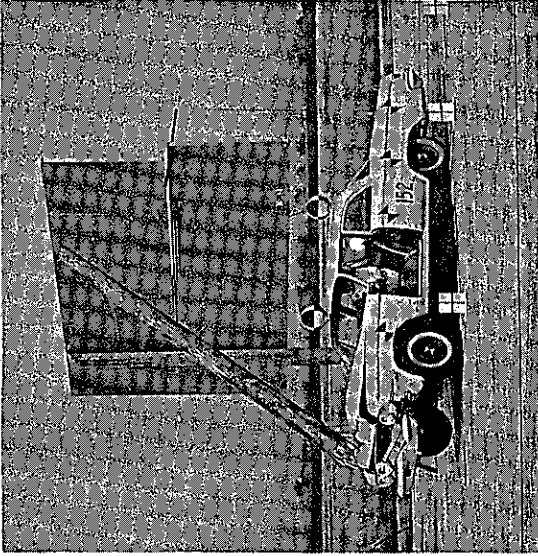
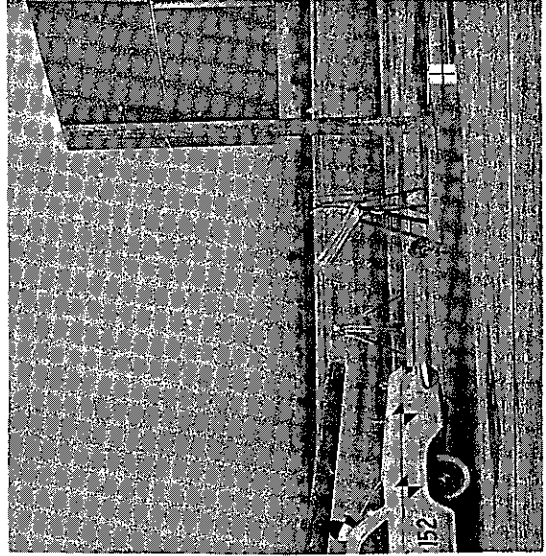
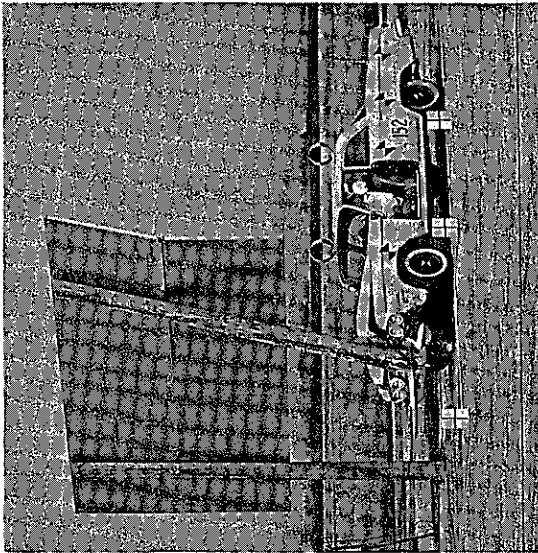
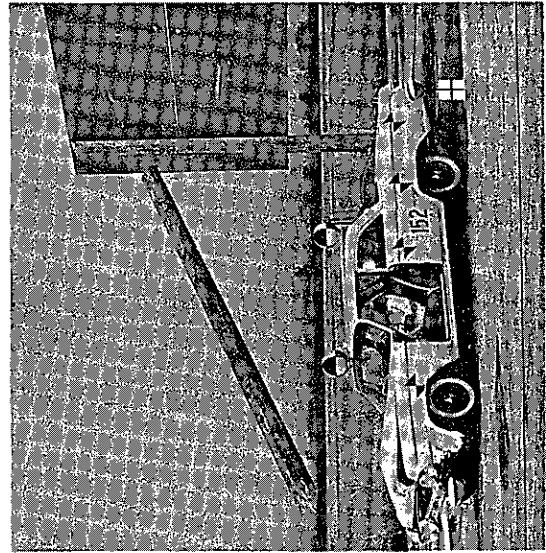
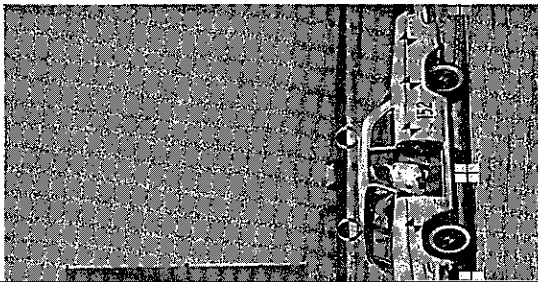
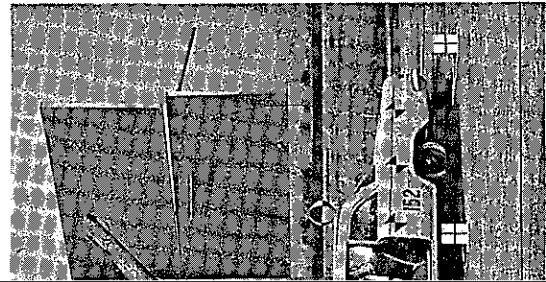
TEST 152 PLATE B

Upon impact the pole broke off 11 in. below ground level and 24 in. above the ground. The upper 15 ft. section of pole tore loose from both sign panels, was flipped up and came down on the crash vehicle deforming the roof and shattering the rear window. The four lag bolts, attaching the sign panels to the pole, pulled out of the impacted pole without damaging the sign panels. The panels remained attached to the right support pole and were used in the subsequent test without repairs.

A review of the high speed data film indicated that the pole failure resulted primarily from excessive bending

The vehicle sustained moderately severe front end sheet metal damage in addition to the aforementioned deformed roof and shattered rear window.

It was concluded that a medium to heavyweight vehicle colliding with a Class 2 timber pole in a manner similar to this test would generally result in tolerable deceleration rates and be a survivable accident. However, because the impact severity of this test did approach marginal magnitudes and the specific conditions of this test were probably less severe than would generally be expected under certain operational conditions, a reduction in impact resistance was considered desirable. It was therefore decided to attempt to reduce the impact resistance of the Class 2 timber pole to make it safer for all conditions of impact. It was considered essential, however, that this be accomplished without sacrificing the ability of the pole to withstand design wind loadings.

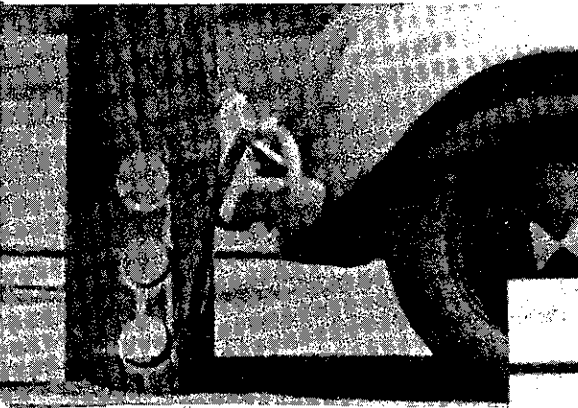
The results of the impact test indicated that this modification was effective in reducing the impact severity. However, analysis of the high speed data film of the impact and evaluation of the appearance of the fractured pole revealed that the type of failure which occurred in the pole was not what had been anticipated.

Prior to this test it was felt that failure would result primarily from excessive shear stress and produce a clean break through one of the weakened planes where the cross sectional area had been reduced. However, the high speed data film revealed that a beam type failure occurred with the wood material splitting between the holes, thus allowing vertical slippage. This let the two sides of the pole break independently of one another. Sequence pictures illustrating this failure are shown in Plate A, Test No. 153, of the Appendix. The appearance of the broken pole after impact is shown in Figure 3.

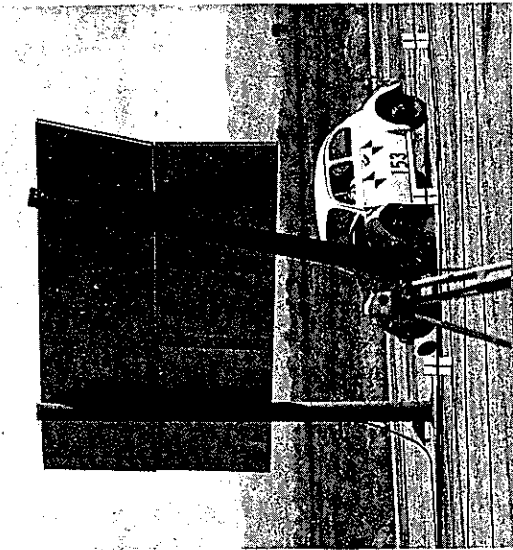
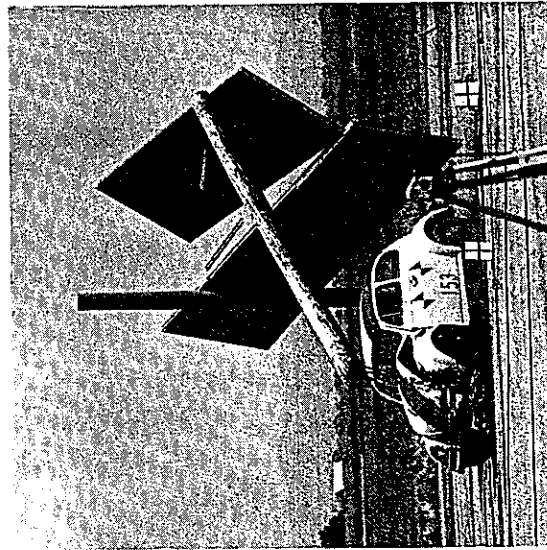
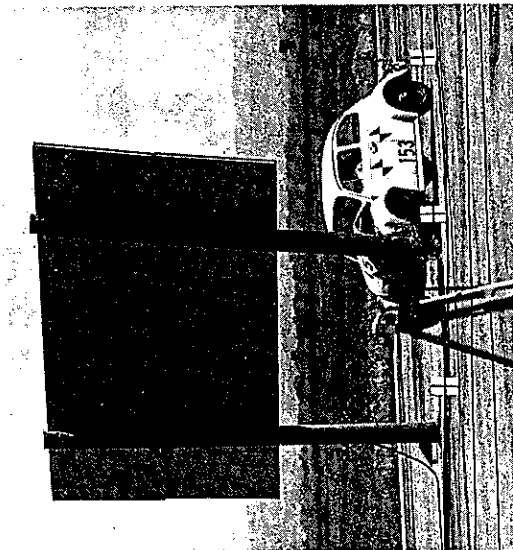
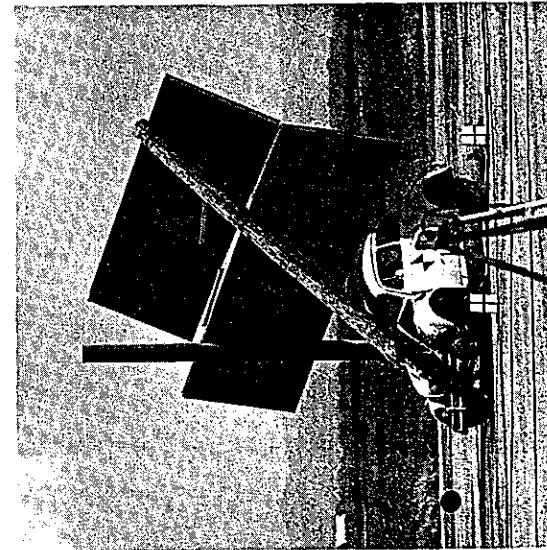
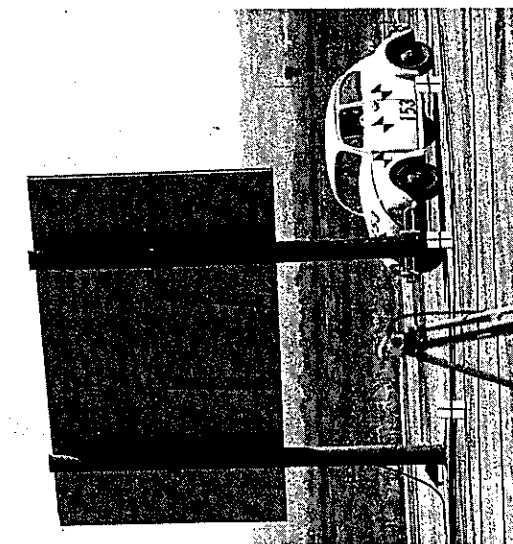
TEST 153 PLATE B

Although failure was not necessarily the result of excessive shear stress, this test did prove that this particular pole modification was effective in reducing the safety hazard presented by a Class 2 pole.

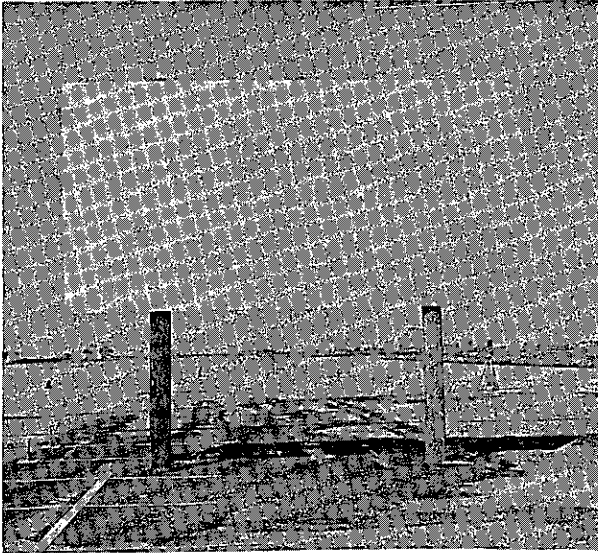
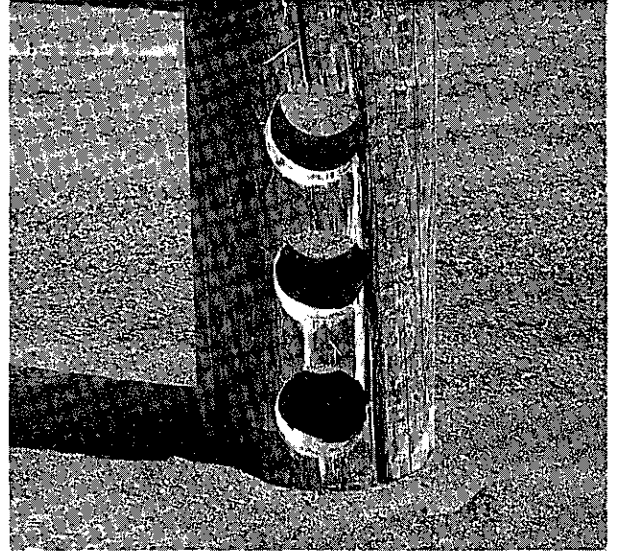
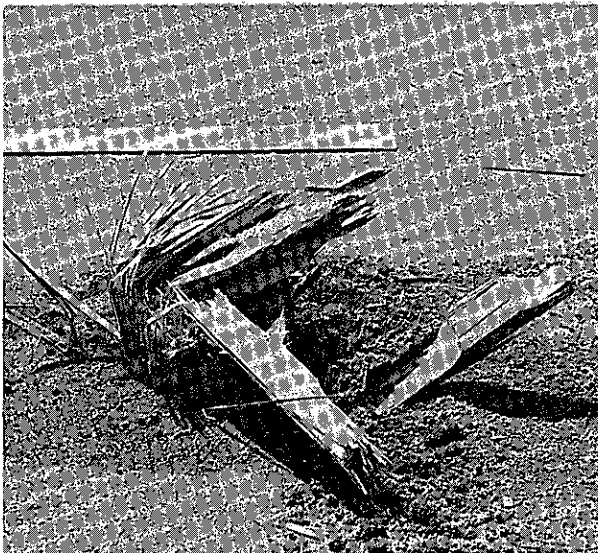
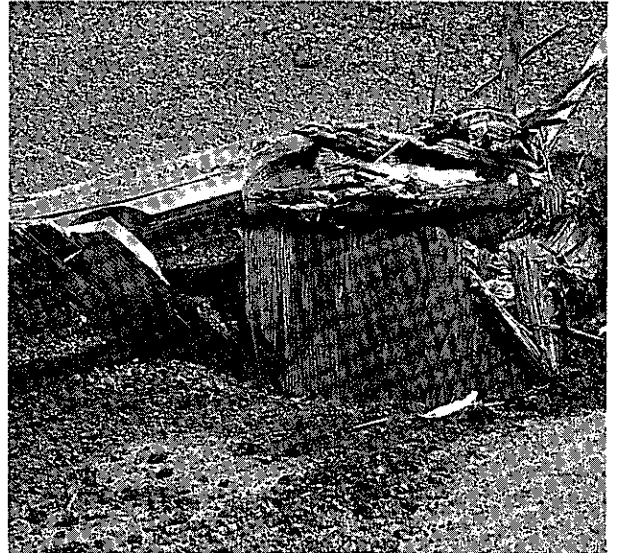
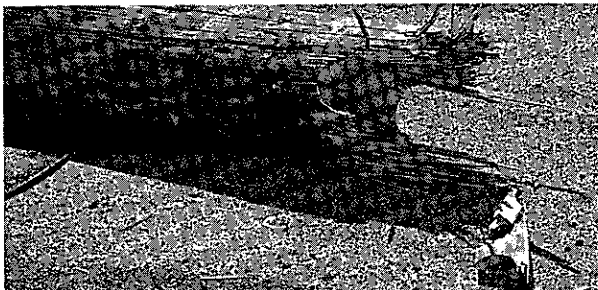
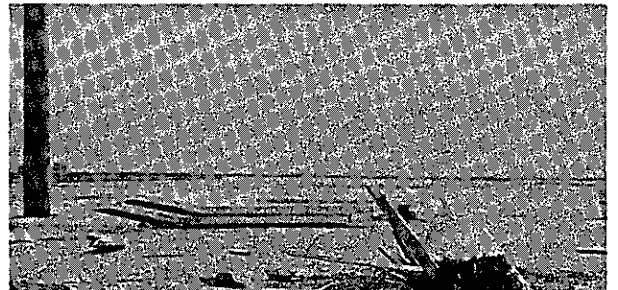
TEST 153 PLATE D

The test vehicle impacted "head-on" into the modified post, at a speed of 39 mph. The vehicle's exit speed was 27 mph. The vehicle was redirected approximately 5 degrees to the left, probably as the result of impact being approximately 1.5 ft. to the left of the vehicle center. The impacted pole fractured at the bottom hole approximately 2 in. above the ground and the section

containing the three holes split in two and was crushed by the force of impact. The remaining 15 ft. of pole was kicked ahead and up, and it tore loose from the sign panels. Had the vehicle not been redirected slightly, it is probable that this section, as it fell, would have struck the vehicle top as in the previous test. The sign panels pulled loose from the other support post and fell to the ground directly below.

The vehicle sustained moderate front end and under-carriage damage with the left front wheel pushed back approximately 6" and the steering column 3". Repair costs were estimated at \$250.
